## Asbestos.....

## Where is asbestos found in buildings?

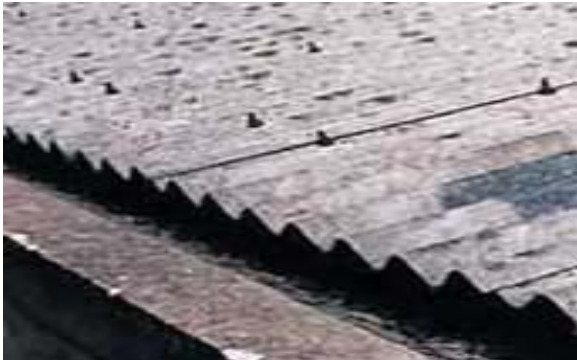
**Figure 1:**  
Asbestos Cement Roofing Sheets

- Sprayed asbestos – generally used as fire protection to structural steelwork, lining within ducts, fire breaks etc.
- Moulded or pre-formed lagging – used in thermal insulation of pipes, boilers, calorifiers etc,
- Insulation boards used for fire protection, thermal insulation, partitioning and duct formation
- Ceiling tiles (Thermal & Acoustic).
- Millboard, paper and asbestos rope products used for insulation of electrical equipment. (Asbestos paper has also been used as a fire-proof facing on wood fibreboard).
- Asbestos cement products, which can be fully or semi-compressed into flat or corrugated sheets, gutters, rainwater pipes and water tanks.
- Textured coatings i.e. 'Artex', 'Wondertex' etc.

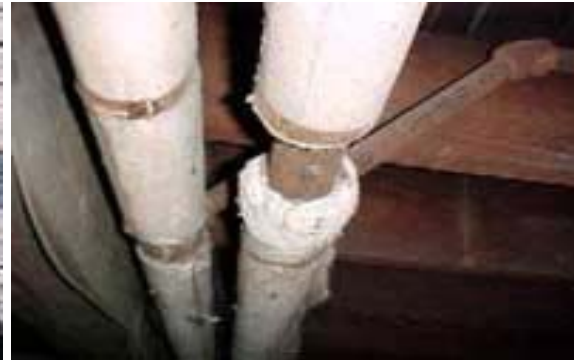
**Figure 2:**  
'Preformed' Thermal Pipe insulation

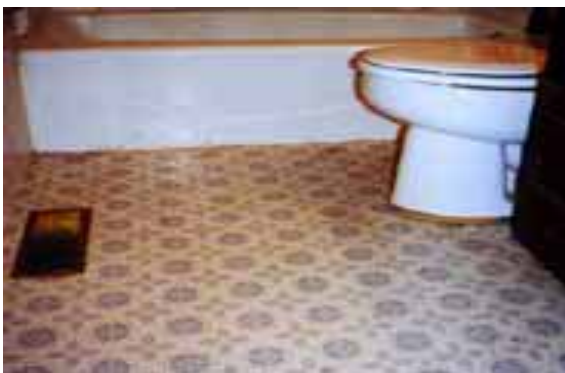
**Figure 3:**  
Floor Vinyl (with Asbestos Paper Backing)

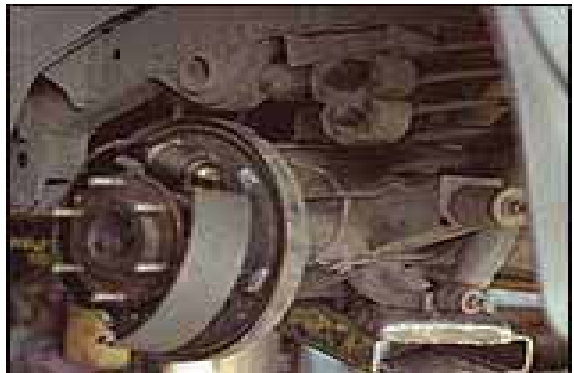
**Figure 4:**  
Brakes containing asbestos rope products

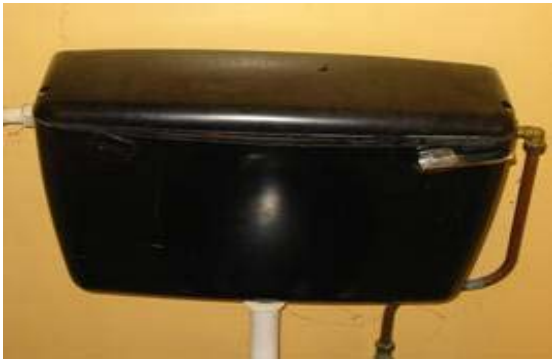
**Figure 5:**  
Bakelite toilet cistern containing  
Bonded asbestos

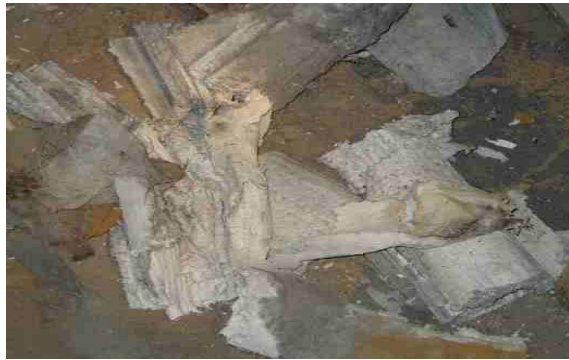
**Figure 6:**  
Asbestos thermal insulation debris  
(contamination)

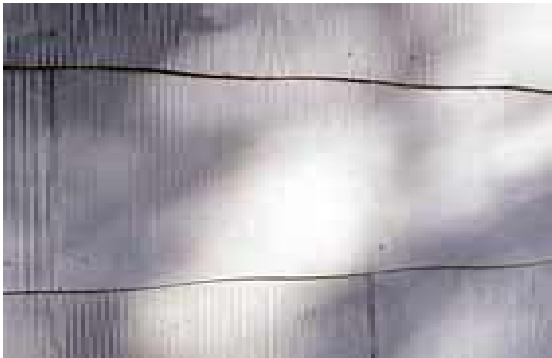
**Figure 7:**  
Sheeting (galbestos) containing  
asbestos

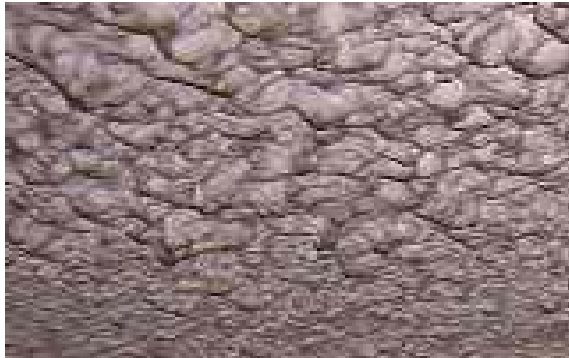
**Figure 8:**  
Asbestos sprayed 'Limpet' coating

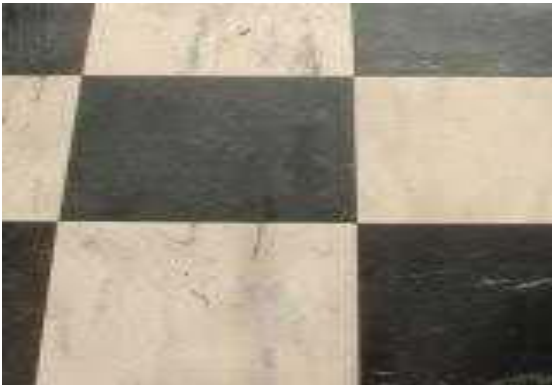
**Figure 9:**  
Asbestos thermoplastic floor tiles  
(Asbestos is often found in the  
Bitumen adhesive beneath tiles)

- Bitumen roofing material.
- Vinyl or thermoplastic floor tiles.

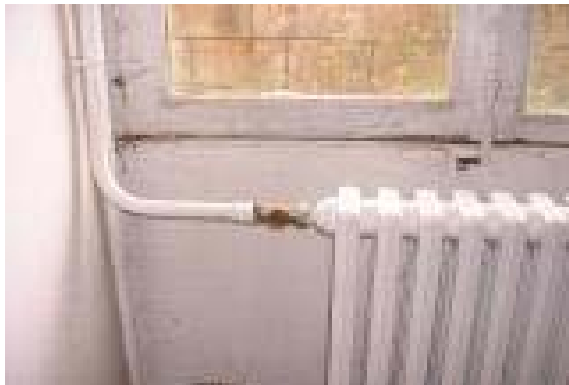
**Figure 10:**  
Asbestos panel behind radiator
